# Subsurface, Inc.

UV CIPP Lining, Culvert Joint Repair, Void Filling, Soil Stabilization, AND MORE!

UV Cured in Place Pipe Lining

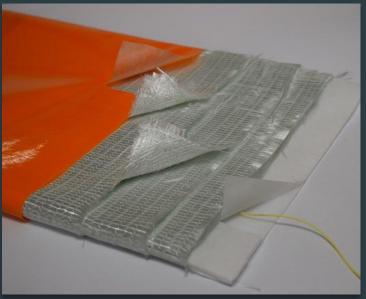
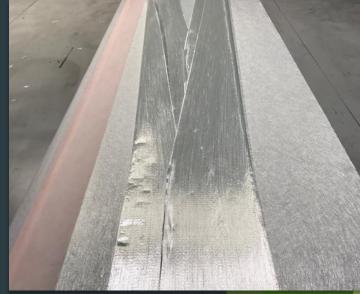
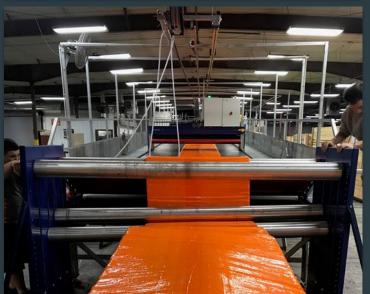
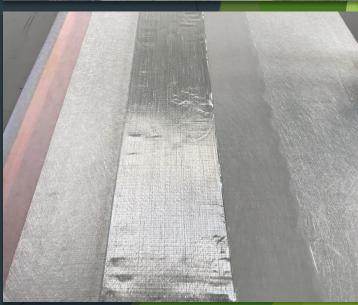
#### **GRP Liner**

#### Outer Foil

- Additional layer of protection
- > Slides easily on the glide foil.
- Creates a barrier between host pipe and liner.
- > UV Light Impermeable

#### Fleece

- Restricts excess movement of resin.
- E-CR Fiberglass (Electrical grade, Corrosion Resistant)
  - Reinforcing Strength and structure.
  - Number of layers of Fiberglass is governed by the ASTM Design Calculations.

#### Resin

- UV light activated
- Strength hardening agent
- Inner Foil
  - Barrier on the inside to contain fiberglass and resin.
  - Inflation foil.

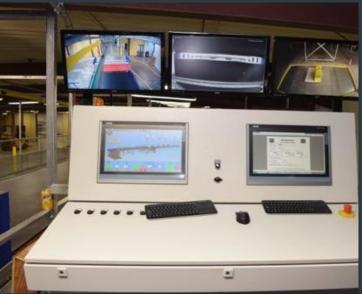
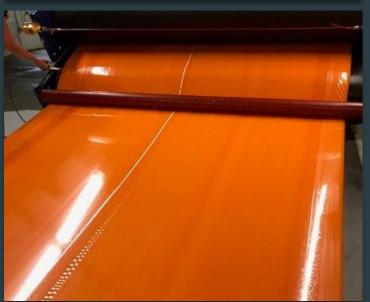
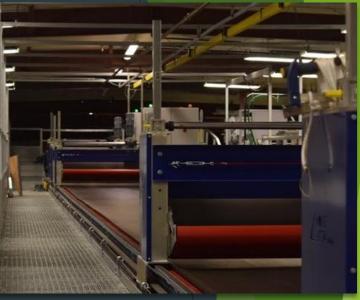
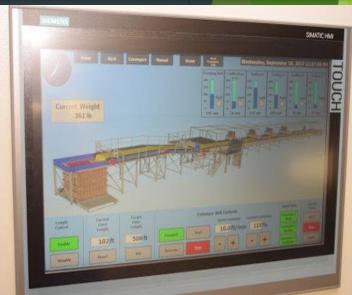
## GRP Liner Impregnation

- Every step of the Liner Impregnation is monitored for quality control purposes.
- Resin is injected into the fiberglass and Pinch Rollers are used to disperse the resin evenly throughout the fiberglass mat.

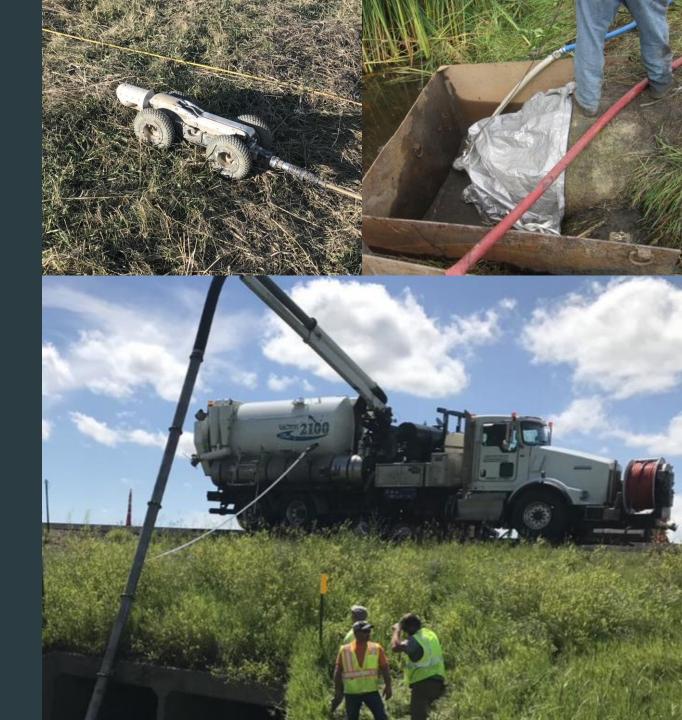
#### Step 1: Clean Existing

Install patented portable steel cofferdams (if needed) to isolate culvert to be lined and enable dewatering Cofferdam and cleaning. Dewater culvert using pumps or truck mounted Dewater suction tube. Clean pipe using high-pressure water jet or other Clean method. Conduct CCTV inspection of the pipe to ensure Televise cleanliness and assess condition of pipe.

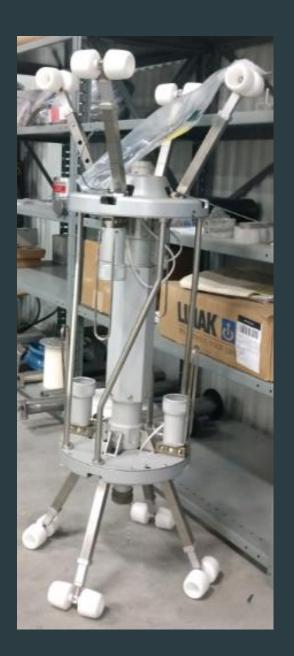
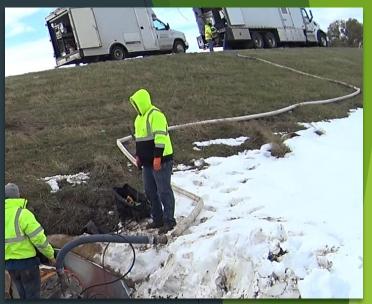
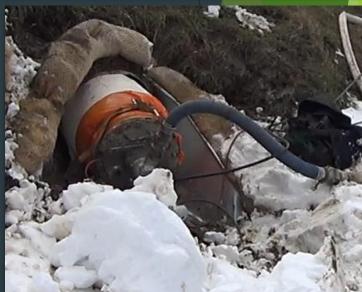
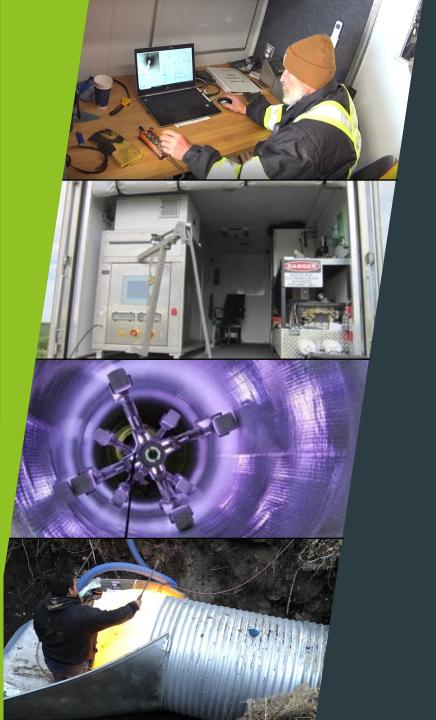
# Step 4: Preparing "Cans" and Light Train

Assemble

Attach blower hose, cable guide, and light train cable.

Expand to Fit

Pressurize in steps to get best fit.

Inspect Fit Light train is pulled through with camera on (no UV light) to the opposite end.

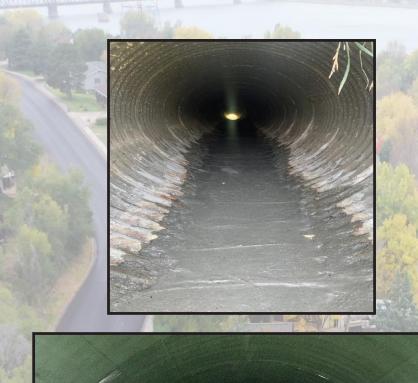
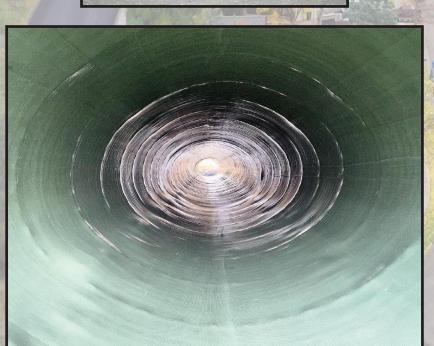
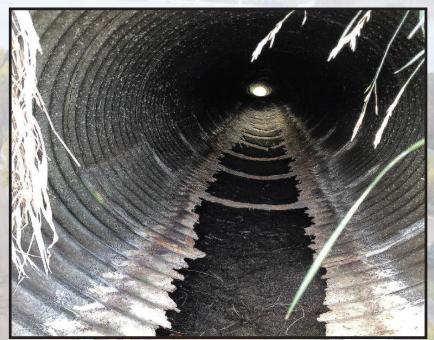
# Step 5 : Full Pressure and Curing Liner

Full Pressure Slowly reach full pressure.

Full Pressure = 2.9 to 4.4 (PSI)

Activate Light Train Activate the light train and begin computer-controlled pull.

Monitor

Monitor the pressure, temperature, and rate of pull. Adjust rate based on temperatures being achieved.

Curing temp = 200-250 (Fahrenheit).

CMP with an invert that is completely deteriorated. A new concrete base was poured and the structure was lined with an Omega Liner Company UV CIPP liner.

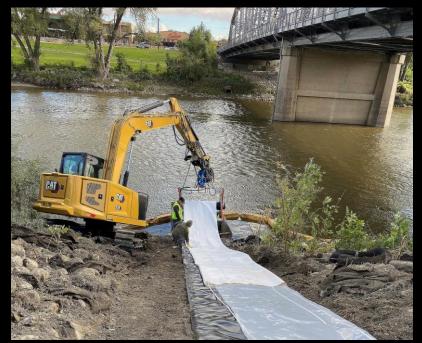
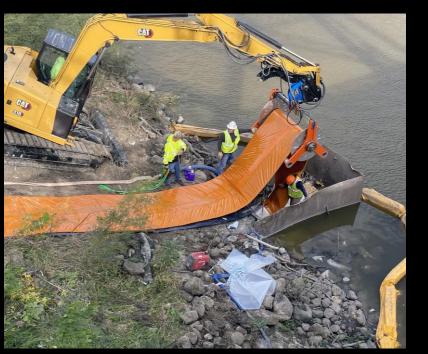
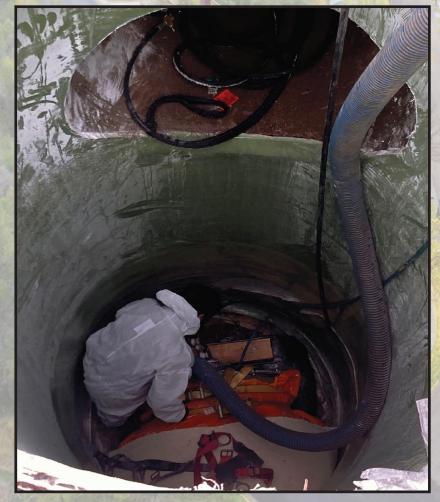
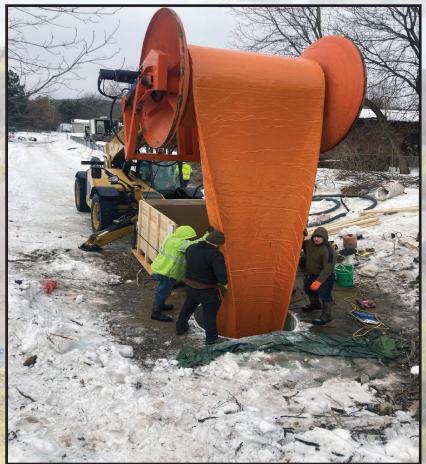
Many different configurations going on here. 42" inlet pipe going into the 60" UV lined vertical pipe then going to a 48" UV lined outlet pipe.

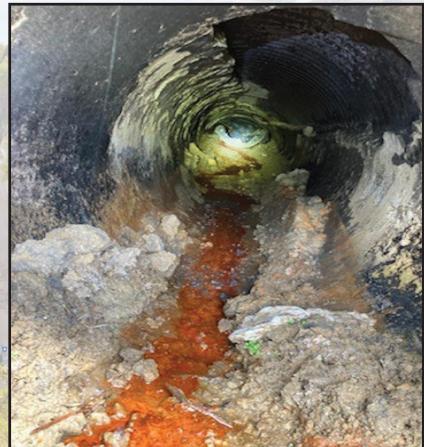
The image above shows a lack of grout filling the annular space in the upper right quadrant of the structure.

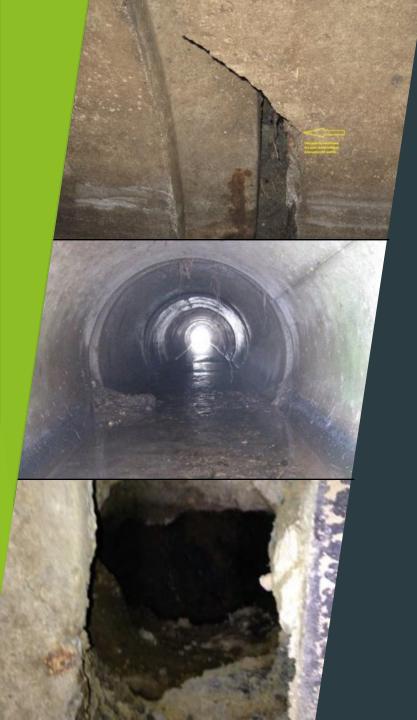
Joint Repair & Void Grouting

- When to consider:
  - Joint Separation
    - When a joint begins to pull apart from freeze thaw cycles, vibration, piping, weakened bedding, poor installation.
  - Joint Displacement
    - After joint separation occurs, often times, the separated pieces will begin to displace vertically.
  - Joint Damage
    - Can occur during installation and be covered up by grout. Also, materials going through culverts can cause damage to joints.
  - Joint Decay
    - Over time, erosion of the concrete can begin to occur. This exposes rebar, aggregate and accelerates joint damage.

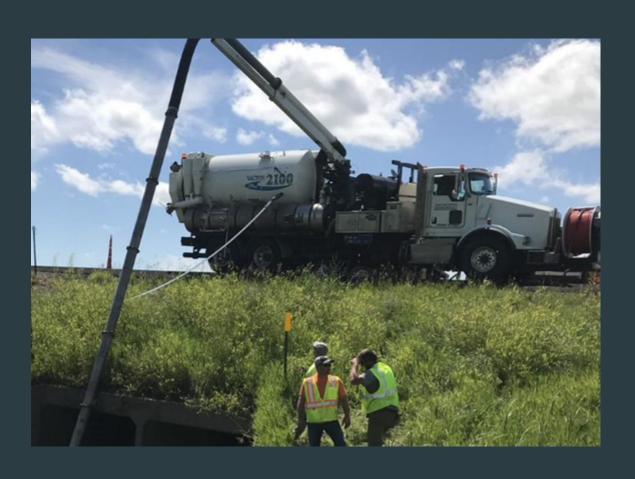
#### Step 1: Cleaning the Culvert and Joints

- If there is standing water or flowing water, patented steel coffer dams coffer dams can be placed, and water can be either be diverted or pumped through/around the structure.
- In order to properly fix the joints, we begin by cleaning the culvert as well as the joints.

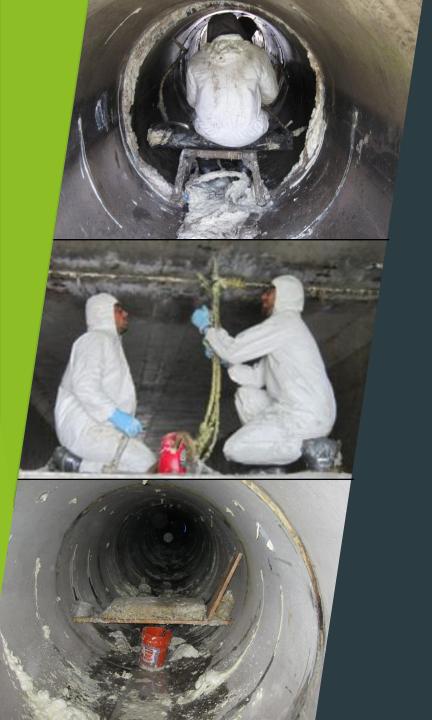
## Step 4: Injection of the Polyurethane Resin on the Backside of the Joint

- The outside of the joint is filled through the drilled injection holes to seal the joint from the backside of the structure.
- ► The polyurethane resin used is flexible, adhesive, and long lasting.

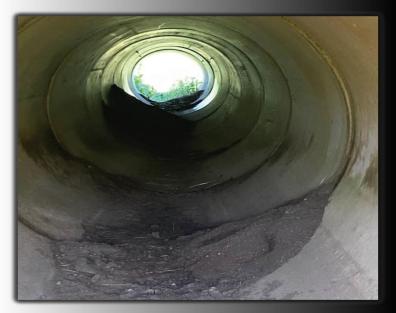
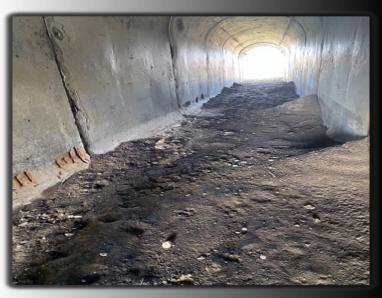
# Step 6: Trim the Excess Oakum and Apply Final Gel Coat

- The final Gel Coat provides a flexible, water resistant seal to the joint as well as UV light protection for the polyurethane grout.
- Retrofitting the joint with tie bars is recommended to provide additional protection against future separation.
